Application of physico-chemical indexes and BMWP / Col. to establish the impact of urbanization on Río Frío (Bucaramanga, Colombia)

Universitas Scientiarum, 23 (1): 109-128, 2018.

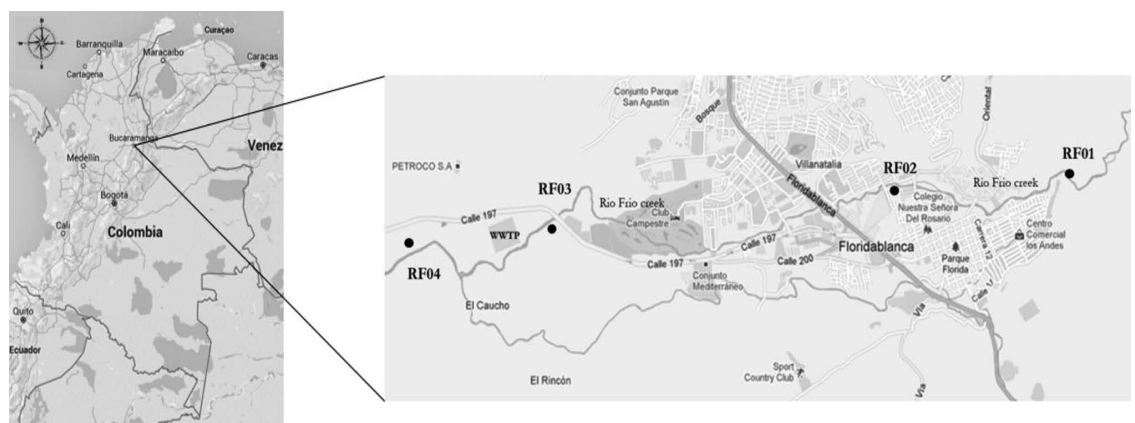
Figure 1. Río Frío (Bucaramanga-Santander-Colombia) sampling sites location. Source: Google Earth map (2016).

Four (4) fixed sites were selected for Río Frío sampling, specifically i. upper middle basin (RF01, aqueduct water intake), ii. two samples collected from the middle of the course evaluated (RF02 and RF03), iii. at the lower basin (RF04) near Río Frío tributary to Río de Oro.

Location of Río Frío sampling sites is presented in **Fig. 1**

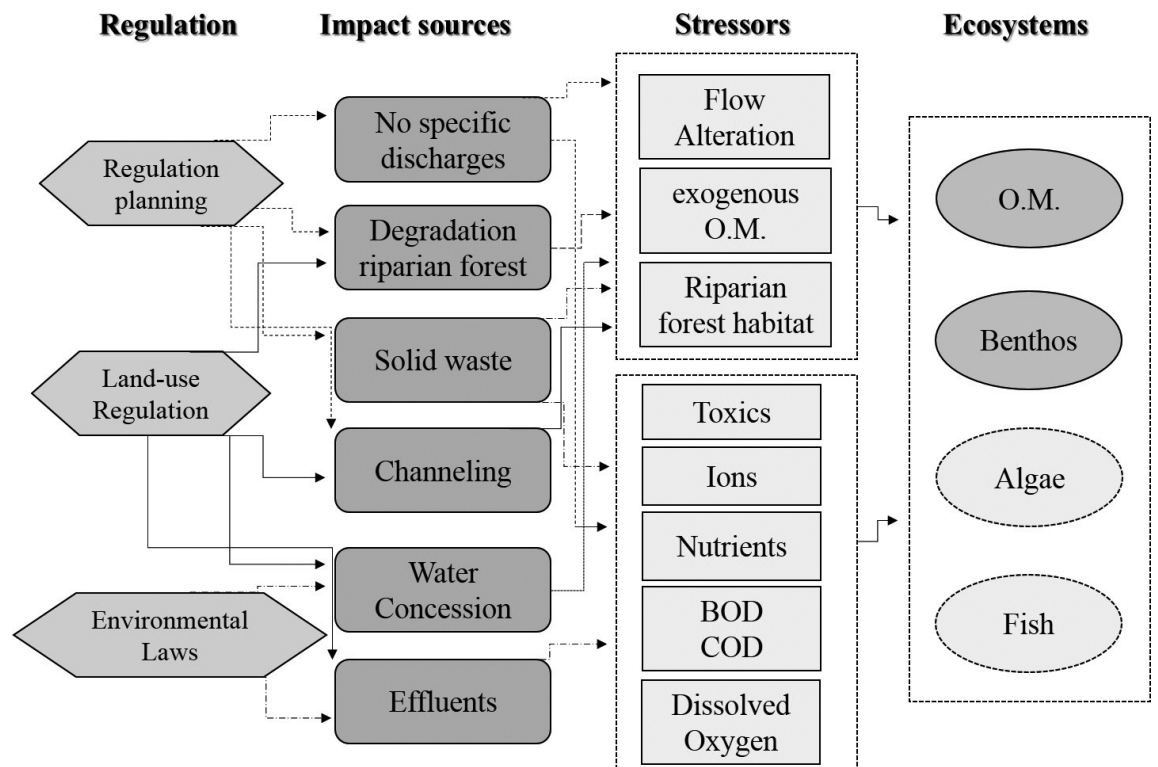
Figure 2. Conceptual model of urban impacts on Río Frío. O.M.: organic matter.

Using Wenger *et al.* 2009 proposed guidelines [32], a conceptual model was structured to establish possible impacts Río Frío receives as an urban stream pilot (Fig. 2).

Likewise, it also serves as guidance for impact identification of urban growth on rivers at a regional level. The diagram is divided into four columns. The first column -regulation- determined regulation instruments involved in urban activity. These include land use planning, which takes into account actions exerted by curators, regional and national territorial planning (*plan de ordenamiento territorial* POT), and current Colombian environmental legislation to protect water, air, soil, and watersheds, among others.

The second column identified sources of impact along the basins. Within this category the first three are related to human urban activity, and the last two to those directly related to legal procedures. The third column determined attributes generating stress in aquatic communities, named stressors. Two types of stressors were acknowledged: exogenous or outside the water or on river or stream banks (water flow alterations, exogenous or external organic matter, - also named contributions - and alterations of riparian forest or gallery forest, accompanying basins). The other type of stressor is endogenous, present in the water column (toxic ions, dissolved gases, nutrients, endogenous organic matter, etc.). Stressors are the result of impact sources. Some may be more influential than others, for example, alteration of riparian forest can have an effect on flow disturbance and the contribution of ions or nutrients to the river [33, 34] in contrast to normal flood fluctuation of the riparian zone.

The last column describes ecosystem components, such as endogenous and exogenous organic matter. In addition, elements of the ecosystem also involve freshwater communities: benthos, fish, and algae. In the present study only benthic macroinvertebrate fauna, organisms that live and develop in the bottom of rivers or lentic systems, was studied [14].
